IMPORTANT PRODUCT INFORMATION

Product: VersaPro™ Programming Software Release 2.02

GFK-1671M

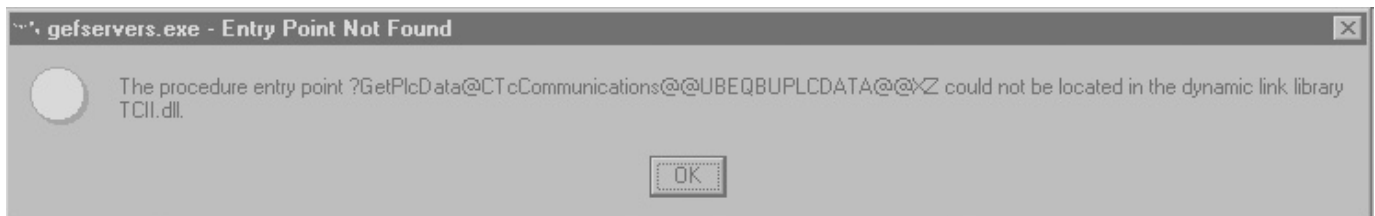
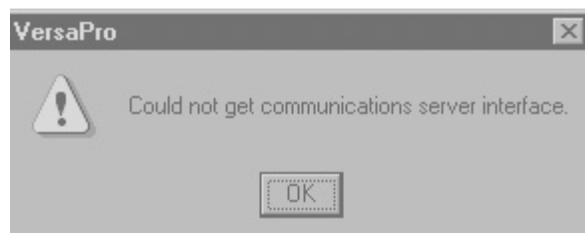
1. **After installing VersaPro 2.0x and then subsequently installing VersaPro 1.0x or 1.1x, you may receive the following error during the installation process:**

In addition, you may not be able to connect to PLCs after the installation completes and the following error message may appear.

Resolution: A VersaPro 2.0x user wishing to install VersaPro 1.0x or VersaPro 1.1x can avoid this problem by following these steps:

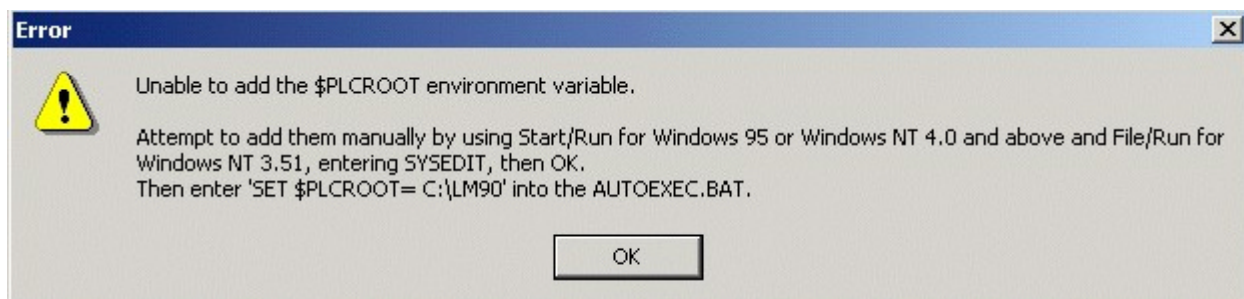
Even though this message occurs, Logicmaster appears to work correctly, but it cannot be guaranteed.

Resolution: Logicmaster should be installed on a PC that supports the Windows 95, Windows 98 or Windows NT operating system.

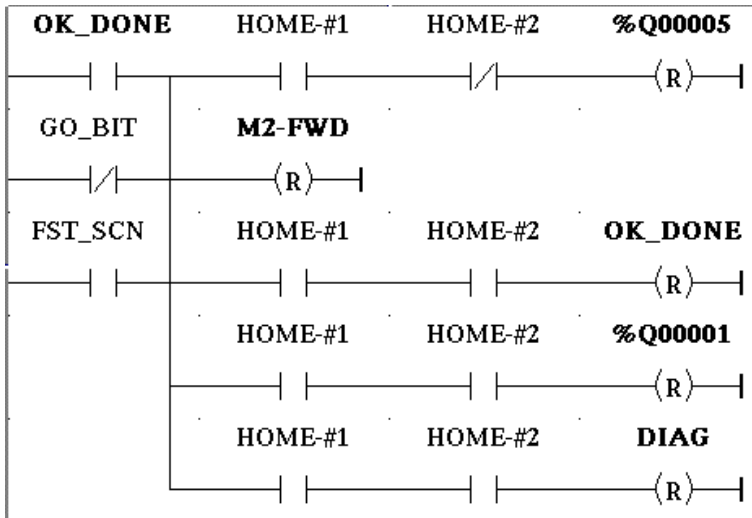
<p>Example 4</p> <p>Resolution: The work around is to add an ALW_ON contact in front of any single coil that has a vertical wire immediately in front of it.</p>

ID	Description
CR71941/ CR71940/ CR71976	<p>Control Version 2.20 VersaMax Configurations can't be imported into VersaPro.</p> <p>Details: Control Version 2.20 VersaMax folders can't be imported into VersaPro.</p> <p>Resolution: Control VersaMax folders should first be opened with Control Release 2.3 and then saved. The updated folder can then be imported into VersaPro.</p>
CR73144	<p>Invalid Program after import and modification of Series 90 Micro LM90 folder.</p> <p>Details: A Logicmaster 90 Micro program that contains a vertical wire immediately in front of a single coil will result in the error 0x05F2 - Invalid Program (or too large for PLC) if it is imported into VersaPro, edited, and then stored to the Series 90 Micro PLC. The Series 90 Micro does not support the optimization that VersaPro performs on this structure.</p>

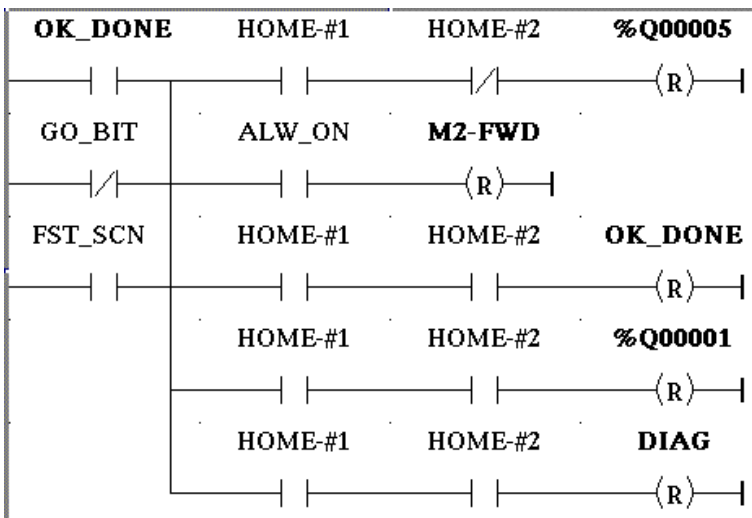
<p>Example 5: An ALW_ON contact was inserted in front of the M2-FWD coil</p>
