# How to recover problems after Windows10 Update

2019.9.12

## About problems that cannot be printed

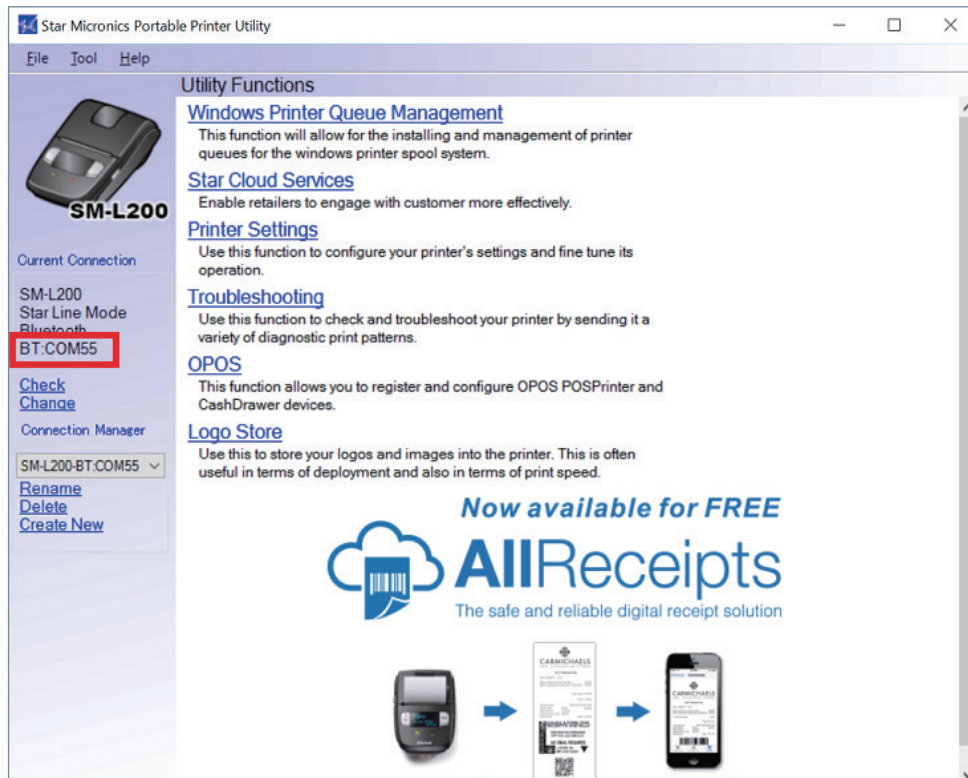
1-1 Run your Printer Utility and check the COM port number of the red frame below.
